**Flood Control Project Maintenance  
Levee Inspections****LMA District Cover Sheet****Spring 2011 Levee Inspection Results****Reclamation District No. 0501 Ryer Island**

**Levee Inspection Report By Mile - Spring 2011**

**Reclamation District No. 0501 Ryer Island**

Waterway							Bank	Unit Miles	Inspection Start/End	Inspector
Unit No. 01 Steamboat Slough							Right	6.76	04/19/2011 04/19/2011	Herman Phillips
LMR No.	Levee Mile		Category	Item	Location *	Rating **	Action/Comment	GPS Latitude/Longitude		Issue No.
	Start	End						Start	End	Photo
1	0.00	0.00	Earthen Levee	Vegetation	LS	M	Control annual grass and weeds on the levee slopes and easements.	38.230288 ° 38.230288 °	-121.603781 ° -121.603781 °	1 Y
2	0.03	0.06	Earthen Levee	Trim / Thin Trees	LS	M	Thin trees to allow visibility of the ground and room to flood fight.	38.254011 ° -121.601810 °	38.253547 ° -121.602264 °	2
3	0.04	0.07	Earthen Levee	Vegetation	WS	M	Remove the wild growth other than native grasses from the levee slopes.	38.230288 ° 38.253518 °	-121.603781 ° -121.602252 °	4
4	0.05	0.06	Earthen Levee	Trim / Thin Trees	LS	M	Trim trees to at least five feet above ground level.	38.253710 ° -121.602098 °	38.253608 ° -12

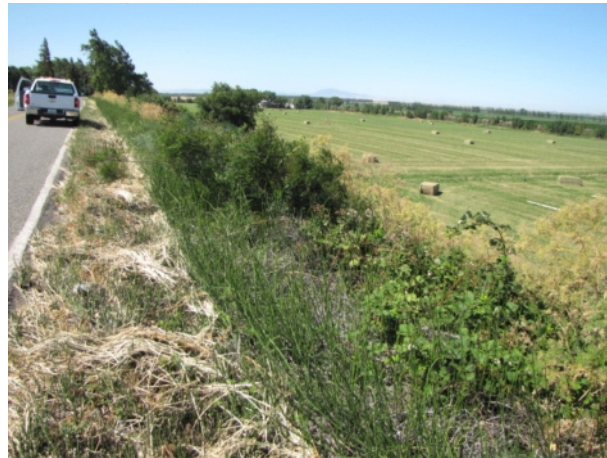
phillips\_s\_20110228\_057.jpg

The berries here completely block the view of the levee section. Standing at levee mile 0.75 looking downstream to levee mile 0.94. Photo taken 11-03-2010

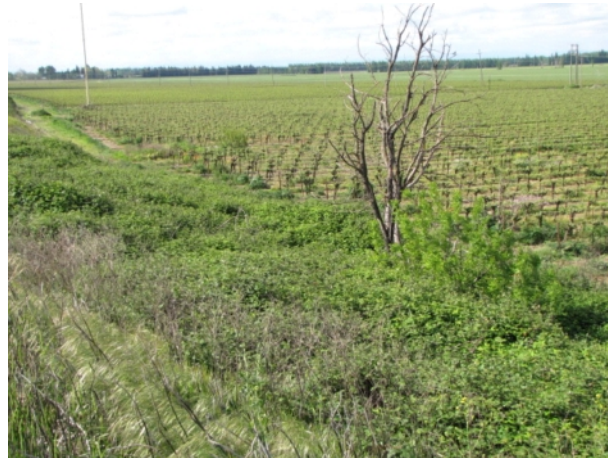
phillips\_s\_20110425\_273.jpg

Levee Mile Report Line	22
Start Levee Mile	1.55
End Levee Mile	1.74
Location	Land Side
Category	Earthen Levee
Item	Vegetation

Another view of the unsatisfactory growth on landside slope. Photo taken 4-19-11.

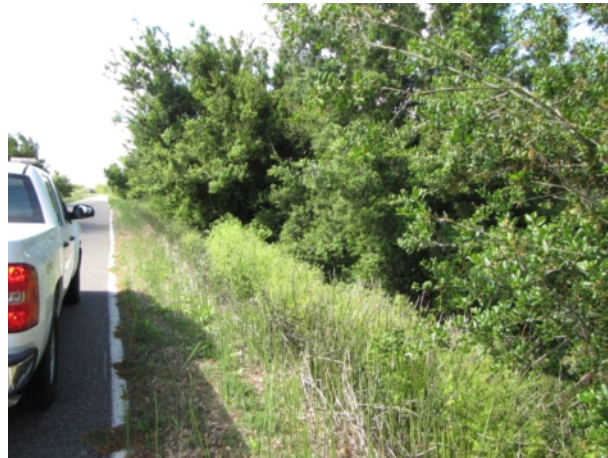
phillips\_s\_20110425\_269.jpg

Levee Mile Report Line	34
Start Levee Mile	3.34
End Levee Mile	3.36
Location	Land Side
Category	Earthen Levee
Item	Trim / Thin Trees

Another photo of the unsatisfactory growth on levee slope from levee mile 3.34 to 3.36. Photo taken 4-19-11.

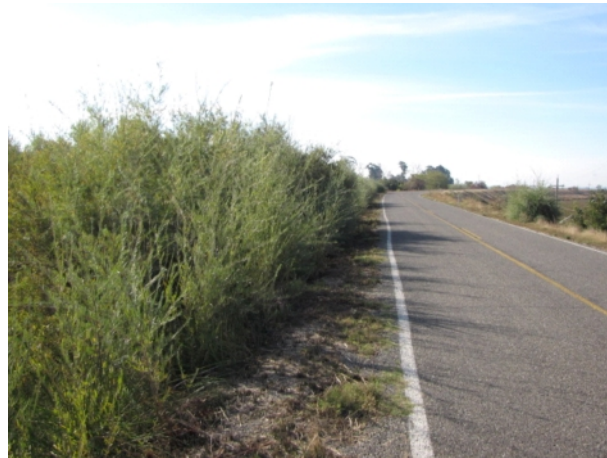
phillips\_s\_20110228\_058.jpg

Levee Mile Report Line	43
Start Levee Mile	4.00
End Levee Mile	4.07
Location	Water Side
Category	Earthen Levee
Item	Vegetation

Looking downstream from levee mile 4.00 waterside sand willows block view of slope. 11-03-2010

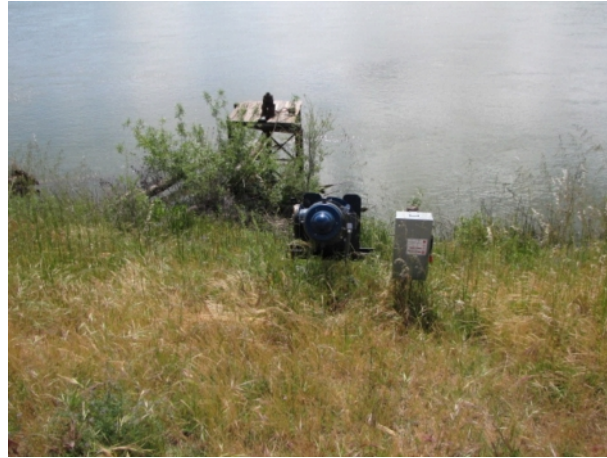
phillips\_s\_20110425\_275.jpg

Photo of unauthorized pipe, pump and electrical box placed on waterward slope.

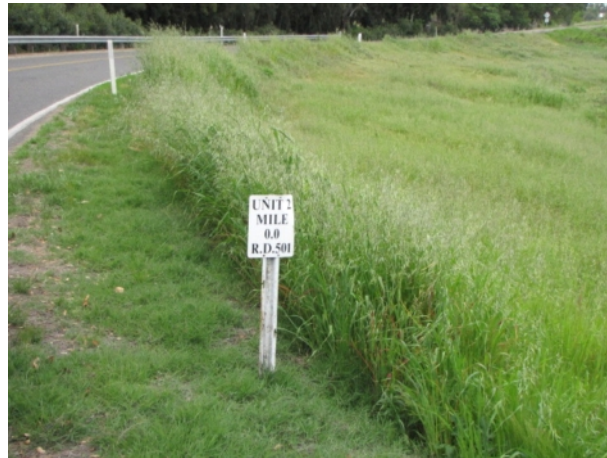
phillips\_s\_20110427\_277.jpg

New photo of Unit 2 landside levee mile 0.00 looking downstream of RD 501. Photo taken 4-19-11.

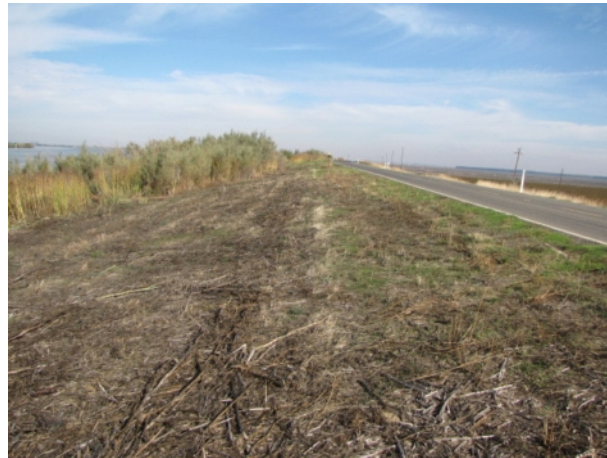
phillips\_s\_20110228\_064.jpg

Water side from levee mile 0.44 looking downstream Unit 2 RD 501. Taken 11-03-2010

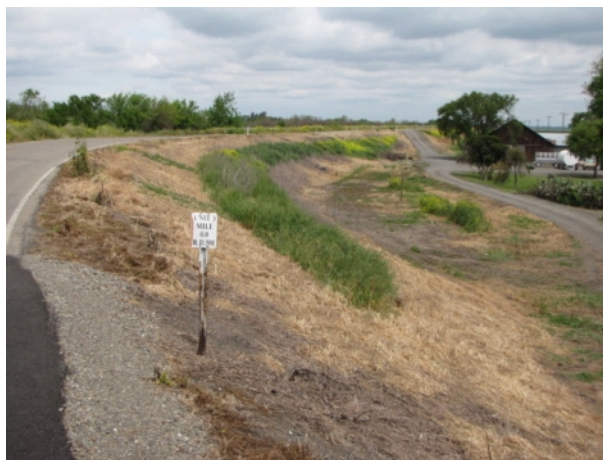
phillips\_s\_20110427\_280.jpg

New photo of Unit 3 levee mile 0.00 looking downstream of the landside of RD 501. Photo taken 4-19-11.

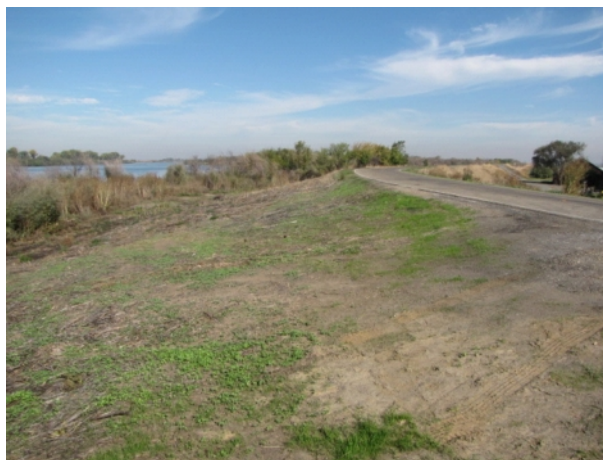
phillips\_s\_20110228\_067.jpg

Standing on waterside levee slope Unit 3 RD 501  
Levee mile 0.00 looking downstream at levee.  
Taken 11-03-2010

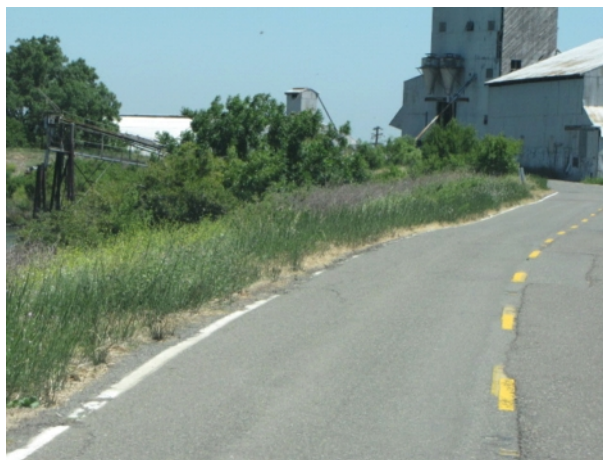
phillips\_s\_20110228\_072.jpg

Looking downstream form Levee mile 3.52 wild growth has overtaken slope on waterside. Taken 11-03-2010

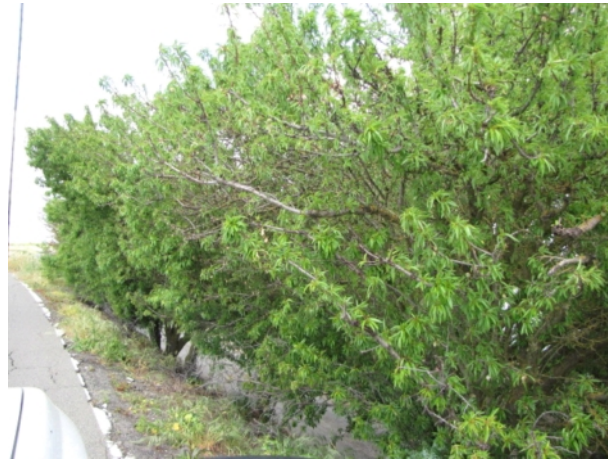
phillips\_s\_20110427\_283.jpg

Levee mile 3.69 to 3.70 new photo of the unsatisfactory growth on the landside levee slope. Photo taken 4-19-11.

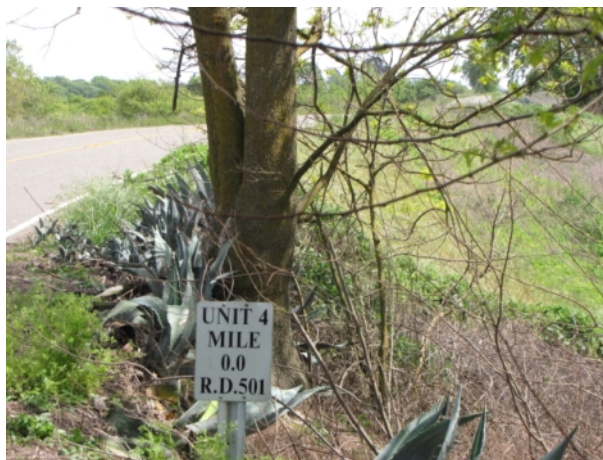
phillips\_s\_20110427\_287.jpg

New photo of unit 4 RD 501 levee mile 0.00 looking downstream. Photo taken 4-19-11.

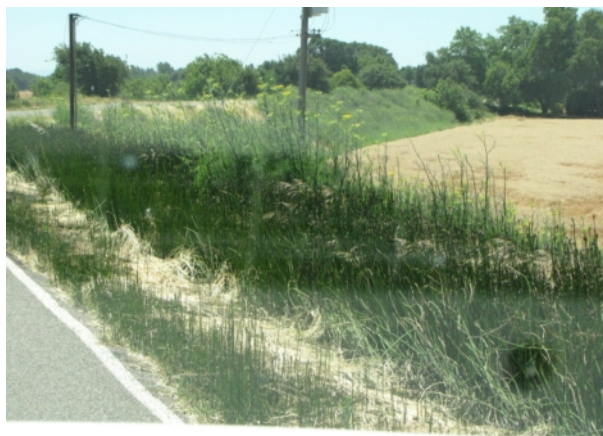
phillips\_s\_20110228\_079.jpg

Looking downstream land side wild growth taking over the slope continuing onward downstream to levee mile 1.15

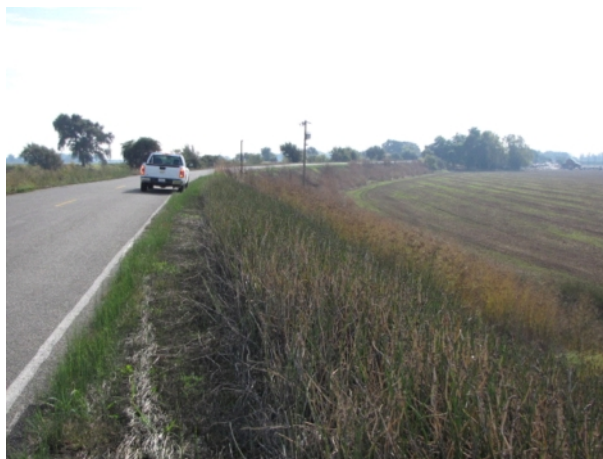
phillips\_s\_20110228\_080.jpg

Levee Mile Report Line	5
Start Levee Mile	0.50
End Levee Mile	1.15
Location	Land Side
Category	Earthen Levee
Item	Vegetation

Standing upstream of levee mile 1.15 Unit 4 RD 501 landside looking downstream at wild growth of Horse Tail on levee slope. You can't see the slope for the growth. Taken 11-03-2010

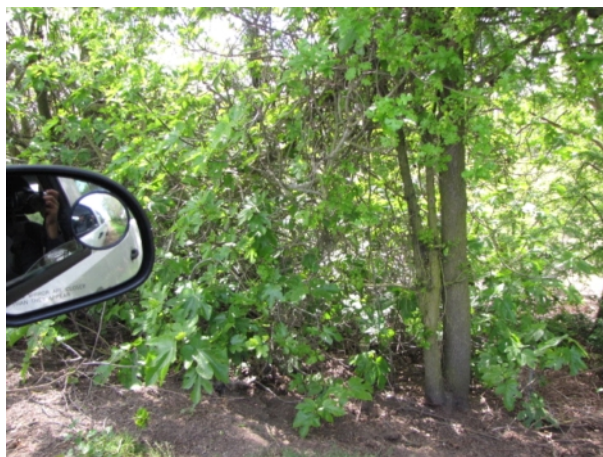
phillips\_s\_20110427\_285.jpg

Levee Mile Report Line	12
Start Levee Mile	1.66
End Levee Mile	1.80
Location	Land Side
Category	Earthen Levee
Item	Vegetation

Levee mile 1.66 landside wild growth to levee mile 1.80 unsatisfactory. Photo taken 4-19-11.

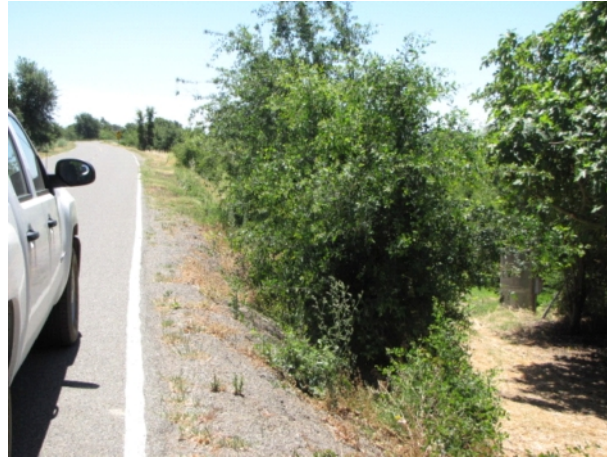
phillips\_s\_20110228\_082.jpg

Levee mile 1.84 looking downstream landside oak tree growth cover slope from hinge point to toe as seen in this photo.

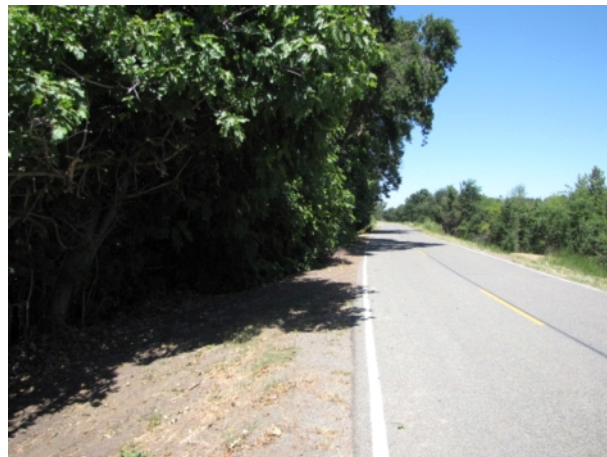
phillips\_s\_20110228\_083.jpg

Levee Mile Report Line	14
Start Levee Mile	1.84
End Levee Mile	1.87
Location	Land Side
Category	Earthen Levee
Item	Trim / Thin Trees

Looking back upstream from landside the fig trees has not been maintained, they block the shoulder and slope of the levee section as well as hanging over the levee.

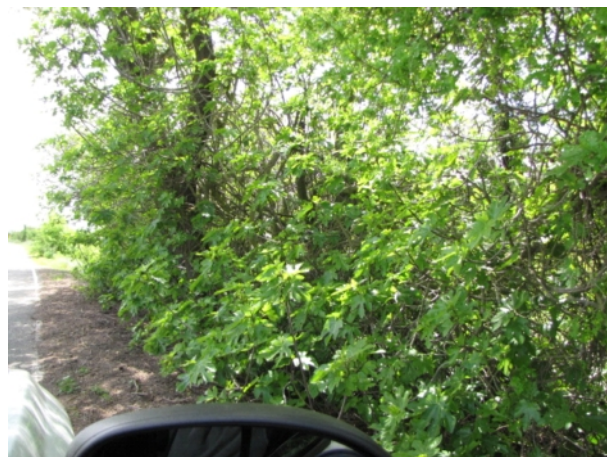
phillips\_s\_20110427\_289.jpg

Levee Mile Report Line	14
Start Levee Mile	1.84
End Levee Mile	1.87
Location	Land Side
Category	Earthen Levee
Item	Trim / Thin Trees

New photo of unsatisfactory growth landside levee mile 1.84. Photo taken 4-19-11.

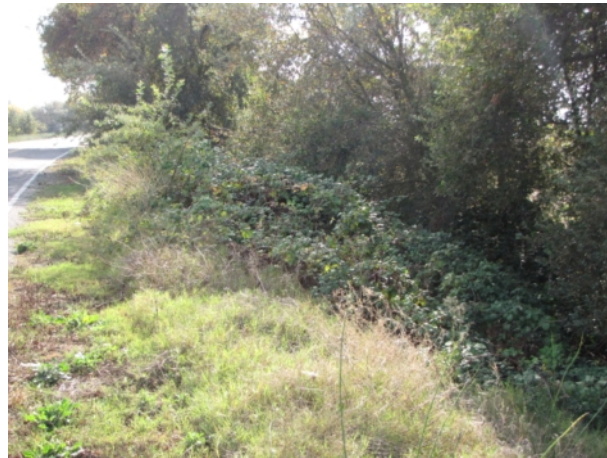
phillips\_s\_20110228\_077.jpg

Standing up stream of levee mile 2.05 looking downstream at unsatisfactory growth of wild berries on landside slope toe and shoulder of levee section. Taken 11-03-2010

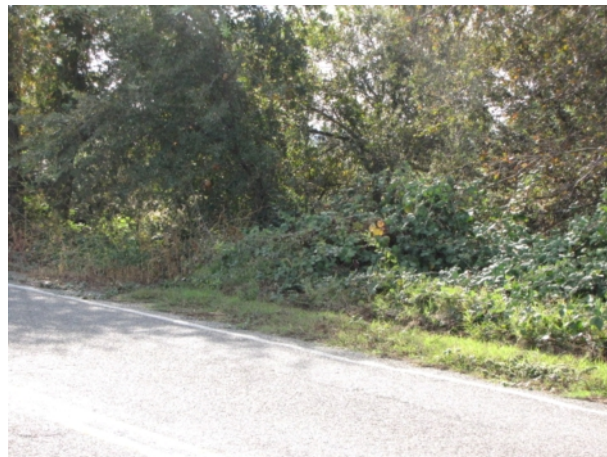
phillips\_s\_20110228\_078.jpg

Levee Mile Report Line	16
Start Levee Mile	2.05
End Levee Mile	2.11
Location	Land Side
Category	Earthen Levee
Item	Vegetation

Downstream view of the wild growth of berries on the landside slope unit 4 RD 501, levee mile 2.11. This wild makes impossible to inspect the levee slope. Taken 11-03-2010
